## HOOD CANAL DRIVE WETLAND MITIGATION SITE PHOTOS

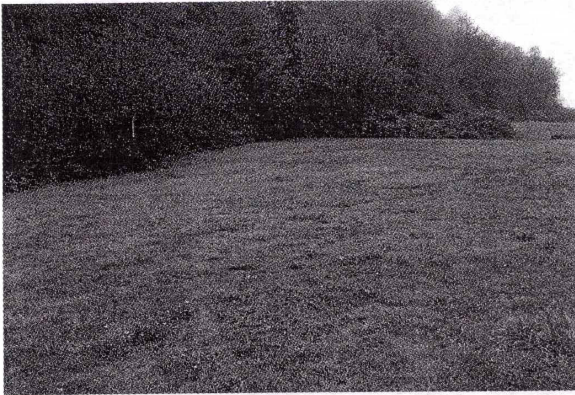
**Photo #1**

This series of photos shows the upper or eastern wetland creation area. Photo 1 looks southwesterly through the mitigation area that will end in the vicinity of the blackberry thicket in the background and extend easterly to the flag (Wetland Boundary flag 13) on the left side of this photo. The ditch from Ponderosa Drive crosses through the blackberry thicket on its way into the forest and the walking path crosses the ditch at the opening in the blackberry on the upper right edge of this photo. Photo #2 looks easterly across what will eventually be the north edge of the eastern mitigation area with the Shorewoods community center in the left background. The eastern wetland mitigation area will extend to the point of the shrub community in the background of this photo or to WB flag 13, which is hanging at the edge of the shrub community and is only barely visible in Photo #2.

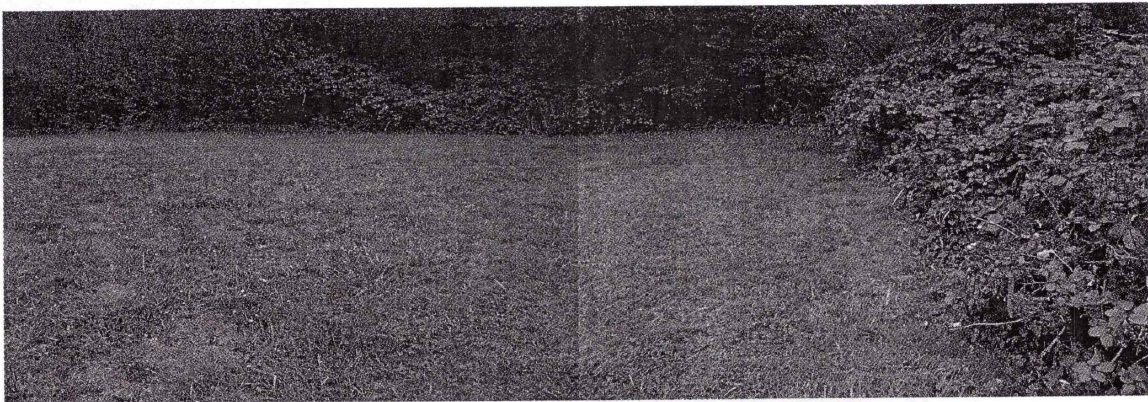
**Photo #3**

Photo 3 was formed from two photos taken from the northern point of the blackberry thicket and they look south to southeasterly across the west end of the mitigation area. The blackberry area is composed of wetland and WB flag #9 is located on the lower right.
